REHOUSE

D4.2

Technical diagnosis (SRI, energy performance, air quality) initial status

Project Acronym	REHOUSE
Project Title	Renovation packagEs for HOlistic improvement of EU's bUILDingS Efficiency, maximizing RES generation and cost-effectiveness
Project Duration	1 October 2022 – 30 September 2026 (48 months)
GA Number	101079951

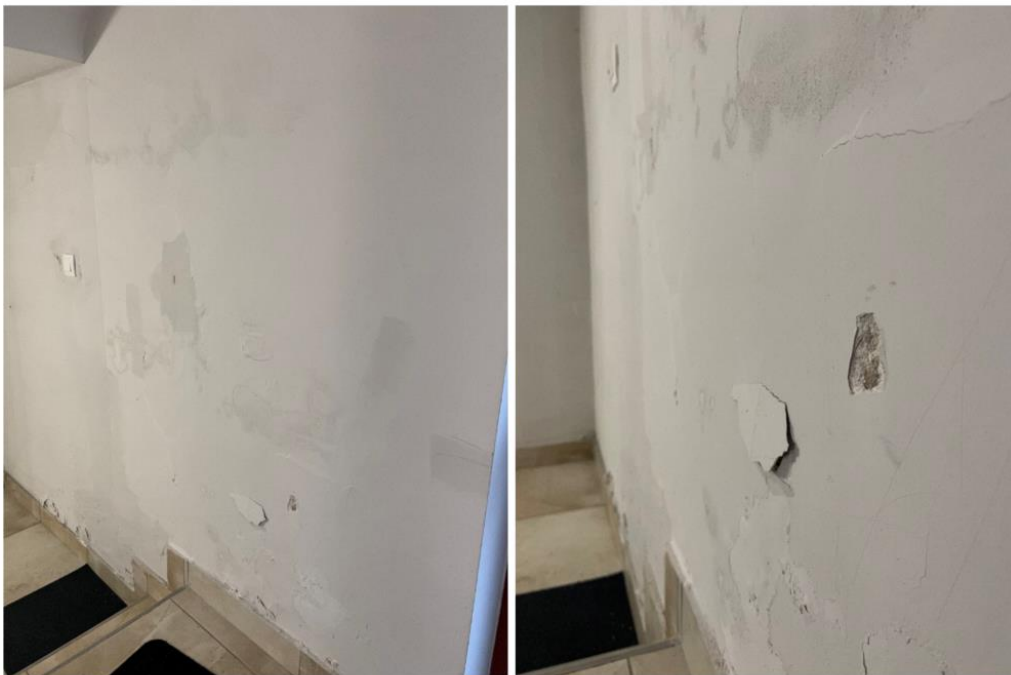
On the first visual investigation was already recognized the strong heat bridge effect of the walls and the lack of regular ventilation. The old brick wall without an insulation provides not a considerable thermal resistance and the insight surface temperature can be low enough to reach the condensation temperature so called dew point on the wall. This phenomenon causes a dramatic problem in the bathrooms, where the humidity usually high easily reach the 100%. The lack of ventilation results in the bathroom molds on the wall surface especially in the corners. The room cannot be dried, because of the regular humidity munition of showering. For seeing the real data, a multisensory was installed to one of the bathroom in the building.

Figure 22: Wall watering in the corridor

It is expected the thermal insulation will help a lot for minimizing or eliminating the heat bridge effect, but the 100% relative humidity is a dew point itself. This could be terminated only by overall or local ventilation of the building.

It should be taken into consideration the high energy content of the vapor over the higher temperature of the bathroom air. The traditional ventilation would have caused a significant energy wasting, by ventilating out the bathroom air without heat exchanger. To gain back this energy the usage of a heat exchanger should be recommended.

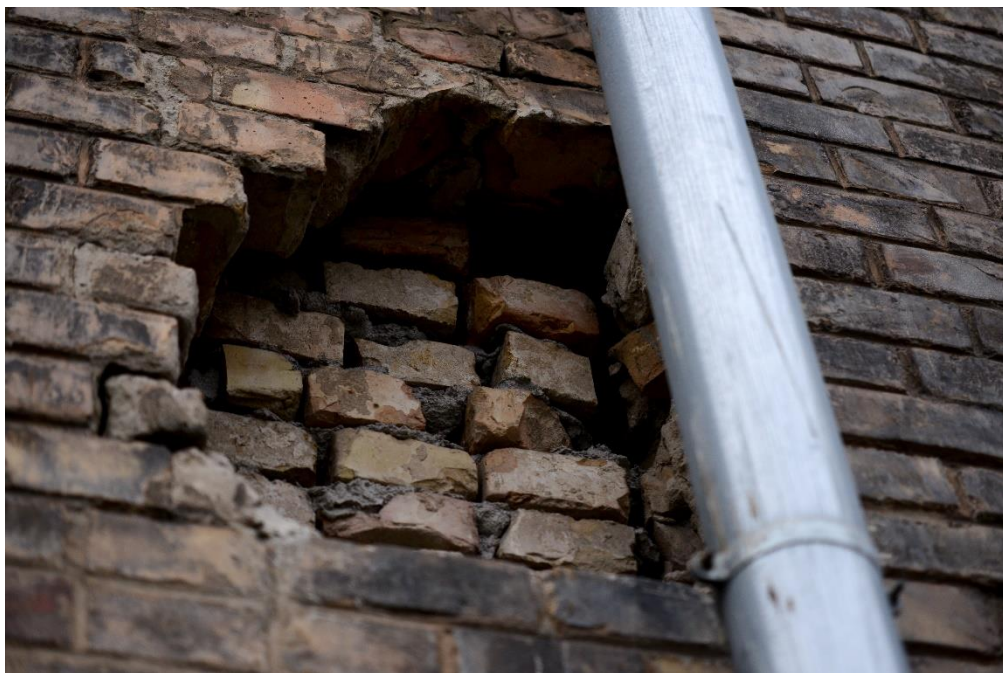
Figure 24: Defect on the exterior brick façade. Original bricks are missing in several places

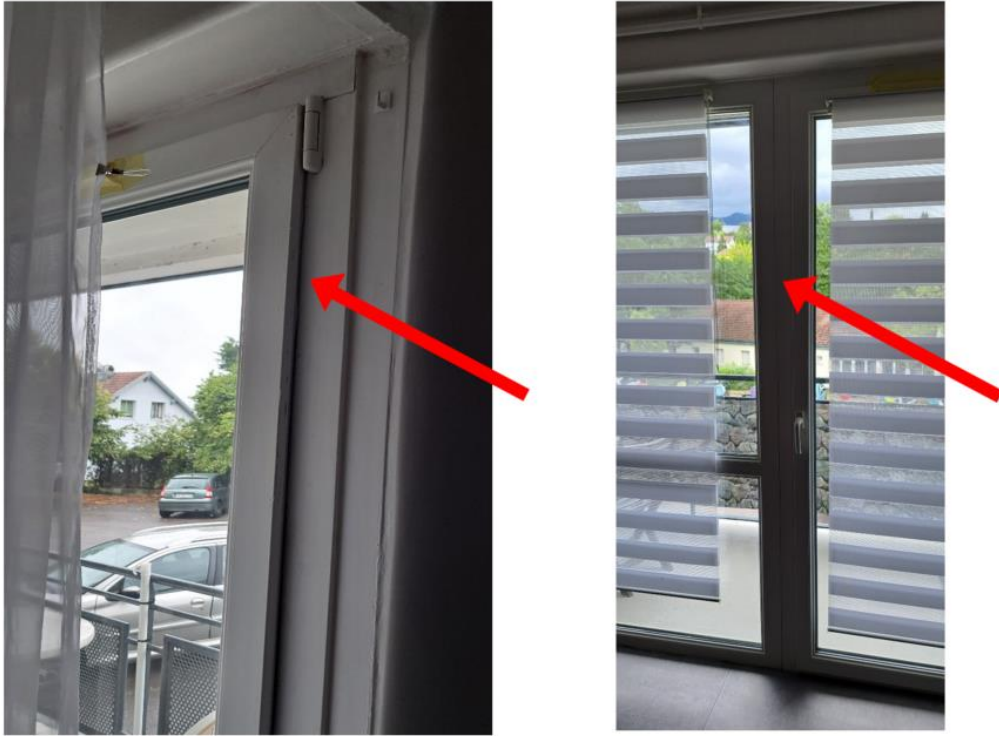
Figure 26: deformation of the sash on the living room French window, creating a gap that the seal no longer covers. joinery seal between living room window and French window

and their connections to the walls treated. The same applies to gas ducts in kitchens and old chimney flues in other rooms. Effective treatment of these main defects should make it possible to reduce leakage rates by a factor of at least 2.

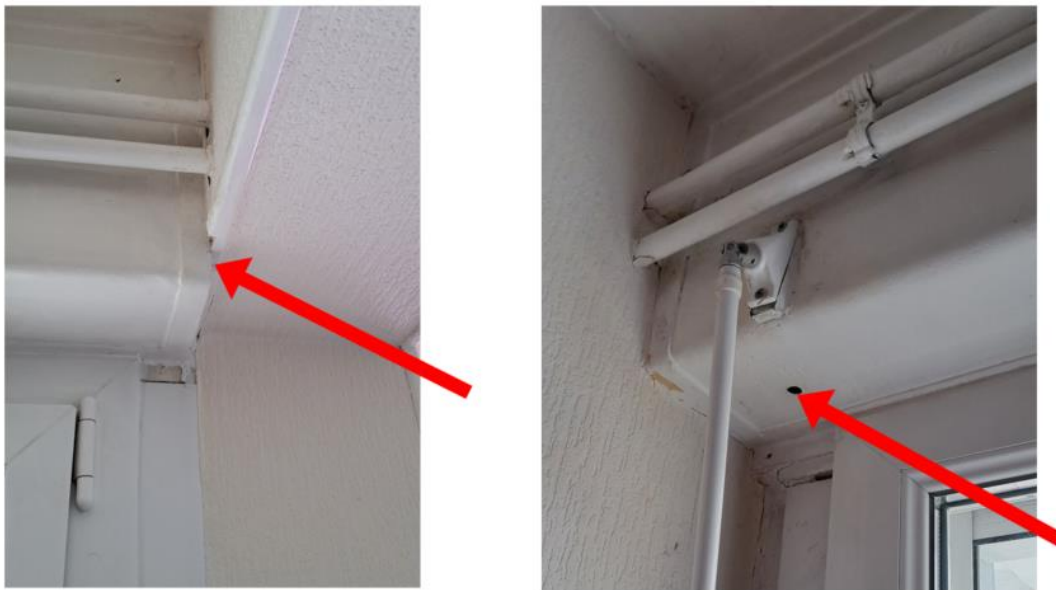
Figure 27: leak at connection in living room. A hole in roller shutter box. Leak in the roller shutter mechanism

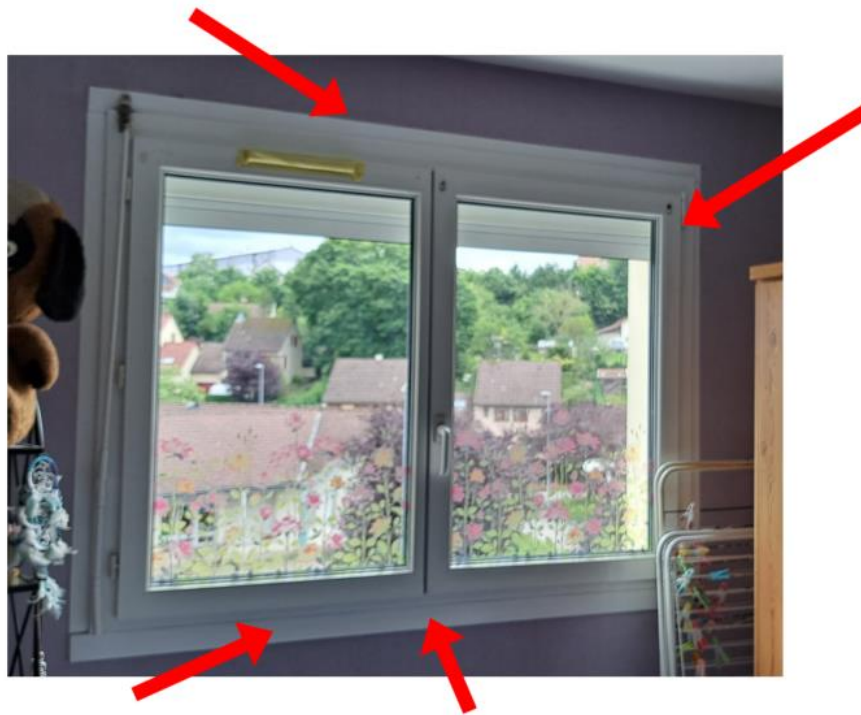
Figure 28: air inlet at wall frame connection.

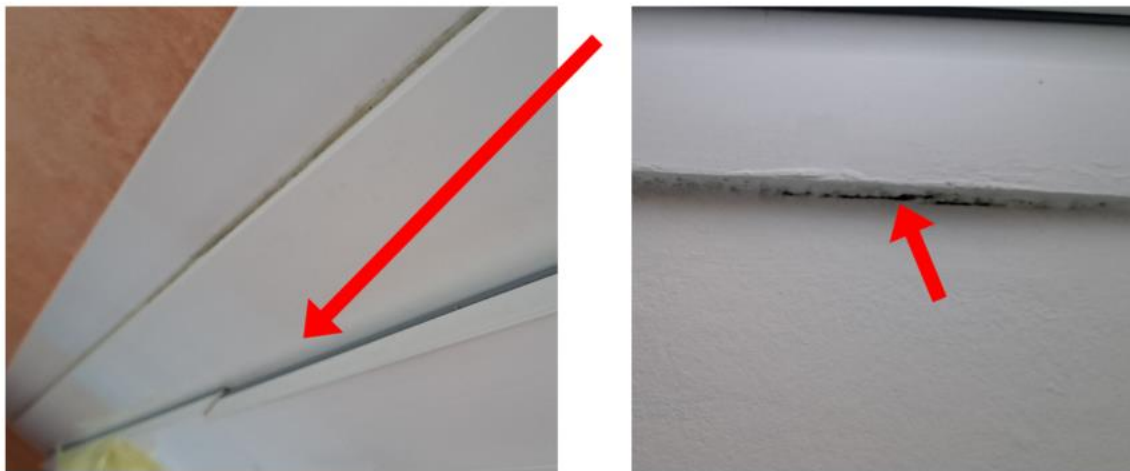
Figure 29: Air intake at top/bottom sash connection. Two windows no longer close properly

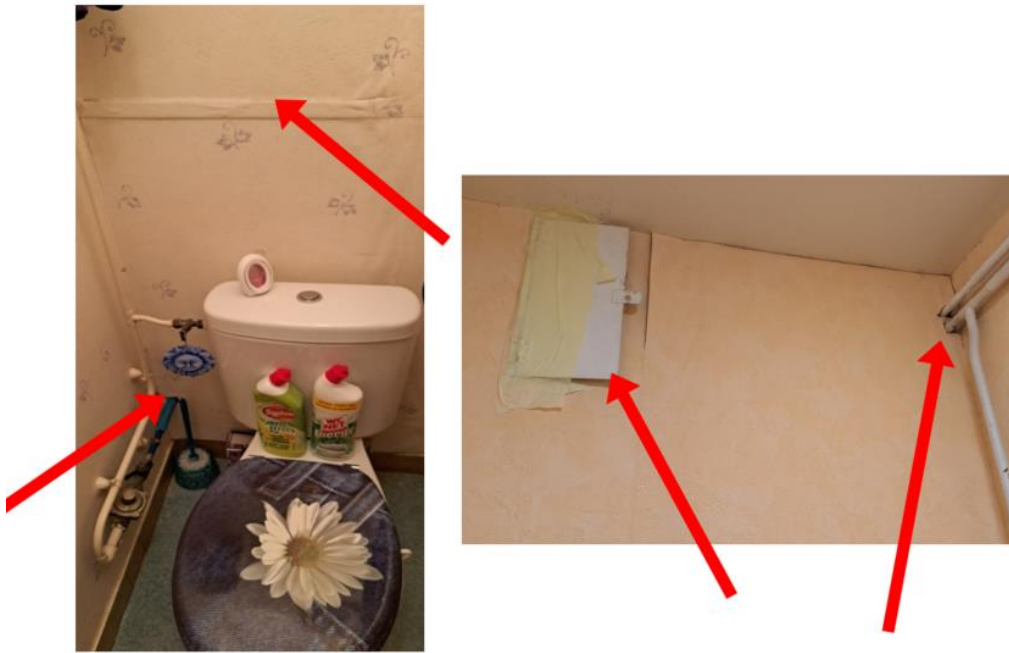
Figure 30: bushings, fittings, natural air extraction

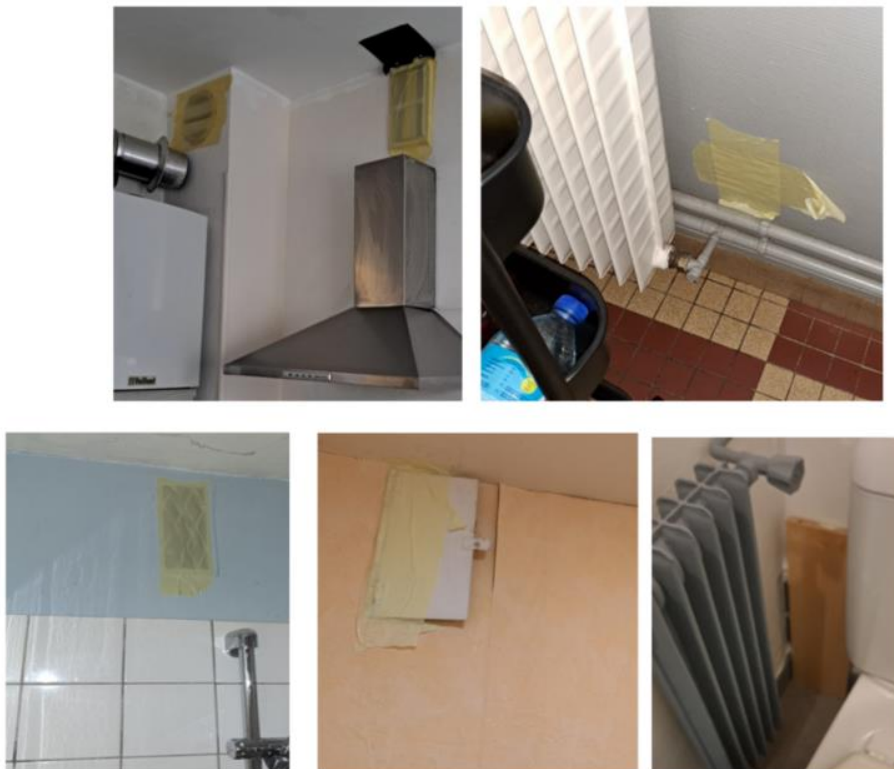
Figure 31: natural air inlet grilles and boiler smoke exhaust

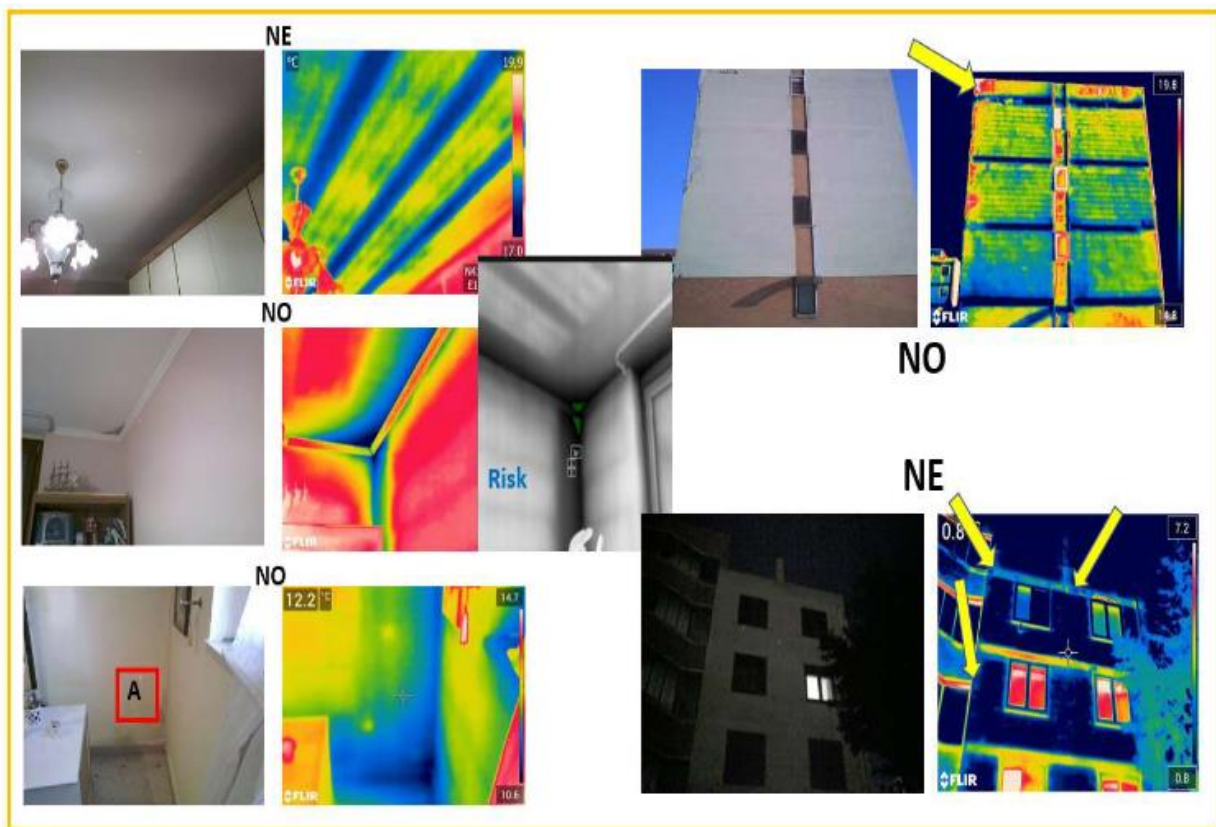
Figure 39: Thermographic analysis indoor and outdoor side NO and NW

In Figure 39, there are thermal bridges, mainly at the terrace slab, at the abutments and at the junction of terrace slab - stairwell parapet. These thermal bridges and infiltration increased heat loss in favour of indoor health issues due to presence of mold and/or condensation

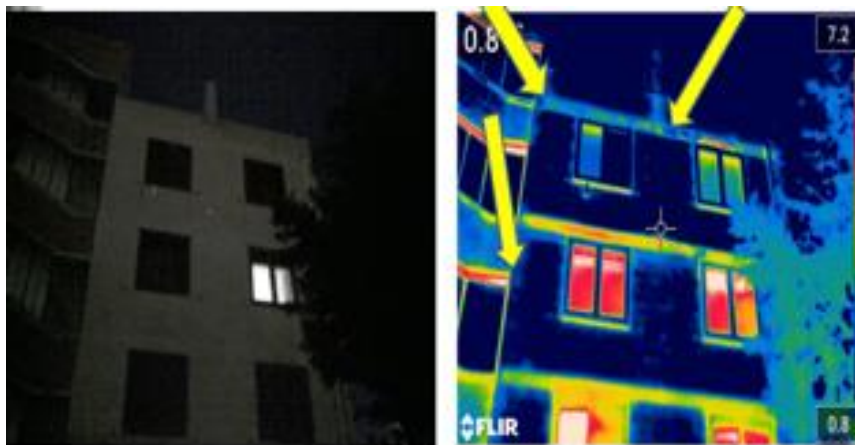
From these investigations, qualitative information is obtained through the thermal image of the analysed area and dimensional information of the degradations detected on the "thermal map" of the anomalous areas. Specifically, from the outside it was possible to evaluate, on the columns, the hygroscopic impact linked to capillary filtrations due to deterioration of the external facade (Figure 80).

Figure 80: photography and thermographic survey of the north-east facade of the Italian Demo Site building.

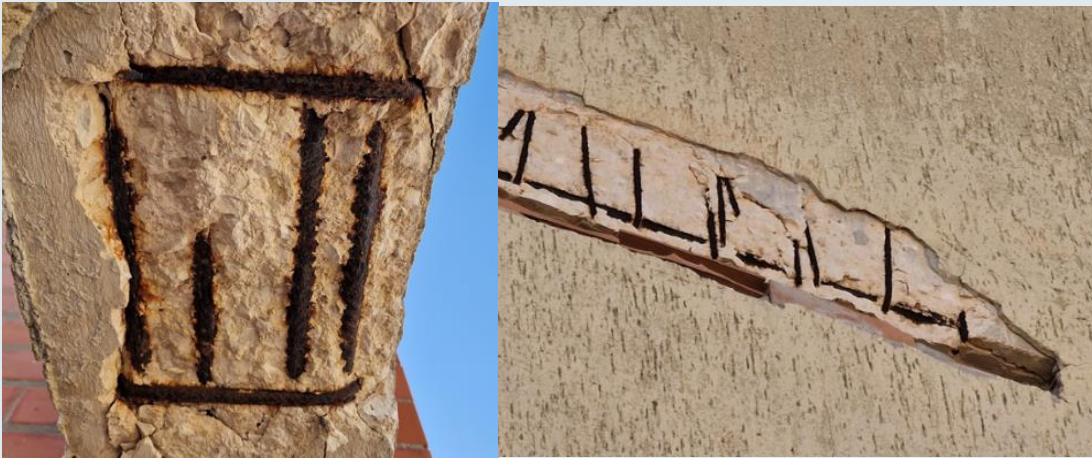
to identify some structural elements where the degradation process of concrete and corrosion of reinforcements is in a rather advanced stage (Figure 81).

Figure 81: Degradation of concrete and corrosion of the reinforcements.

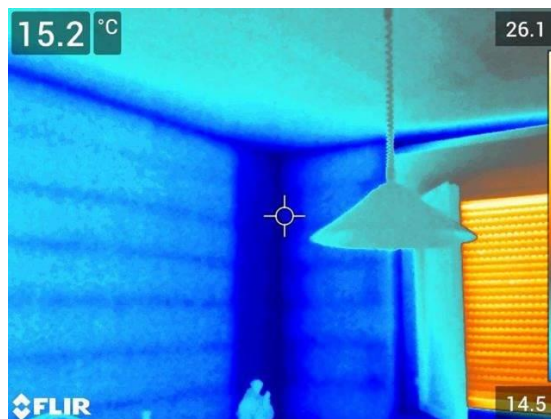
Figure 86: Upper ground floor plan, apartment A, room 6. Thermographic image T2576.

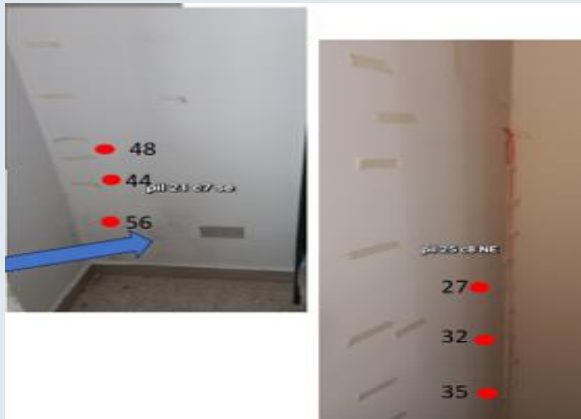
At a later stage, the hygrometric measurements allowed to confirm the infiltration phenomena by analysing, from the inside, the wall structures, the columns (Figure 87) and finally by carrying out measurements on the extracted cores (Figure 88).

Figure 87: Wall and column thermo-hygrometric measurements

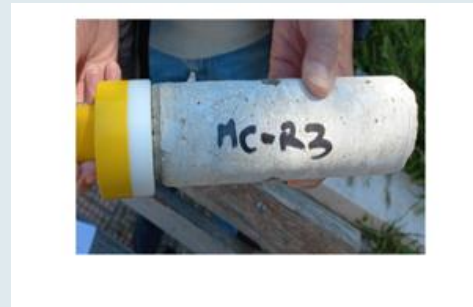
Figure 88: Thermo-hygrometric measurements on core.
