REHOUSE

D4.2

Technical diagnosis (SRI, energy performance, air quality) initial status

Project Acronym	REHOUSE
Project Title	Renovation packagEs for HOlistic improvement of EU's bUILDingS Efficiency, maximizing RES generation and cost-effectiveness
Project Duration	1 October 2022 – 30 September 2026 (48 months)
GA Number	101079951

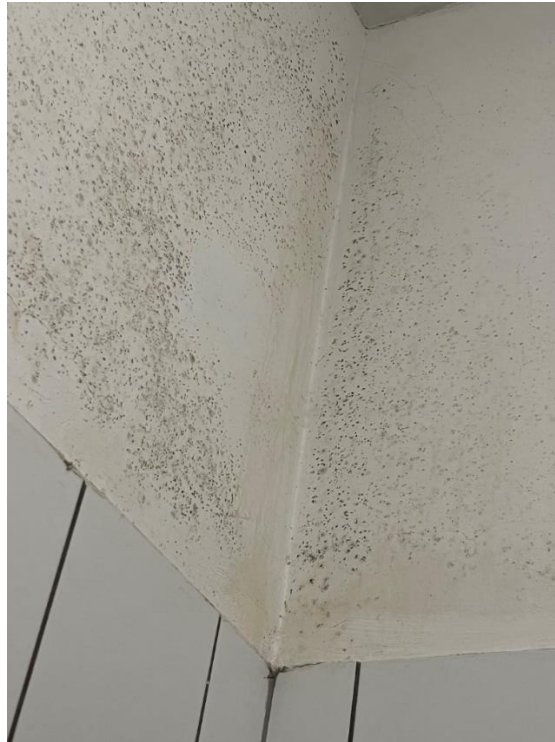
On the first visual investigation was already recognized the strong heat bridge effect of the walls and the lack of regular ventilation. The old brick wall without an insulation provides not a considerable thermal resistance and the insight surface temperature can be low enough to reach the condensation temperature so called dew point on the wall. This phenomenon causes a dramatic problem in the bathrooms, where the humidity usually high easily reach the 100%. The lack of ventilation results in the bathroom molds on the wall surface especially in the corners. The room cannot be dried, because of the regular humidity munition of showering. For seeing the real data, a multisensory was installed to one of the bathroom in the building.

Figure 23: Molds on the wall surface especially in the corners in the bathroom

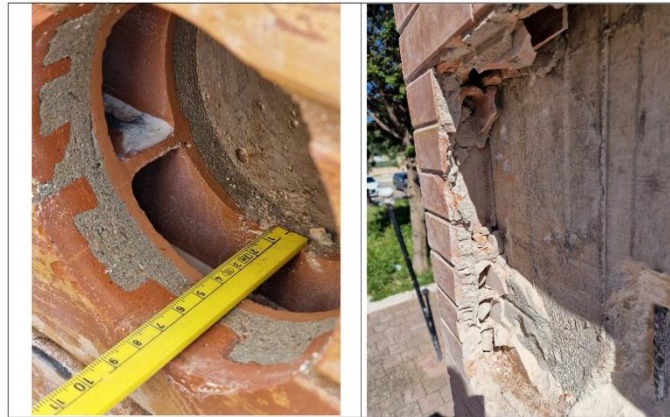
The transmittance, used in the simulation software, was calculated from the results of coring tests performed on the wall package.

Figure 36: Results of the coring tests

The stratigraphy is visible from the coring tests, and four layers were considered and modelled in TeRMUS software. The results are reported in the following diagrams:

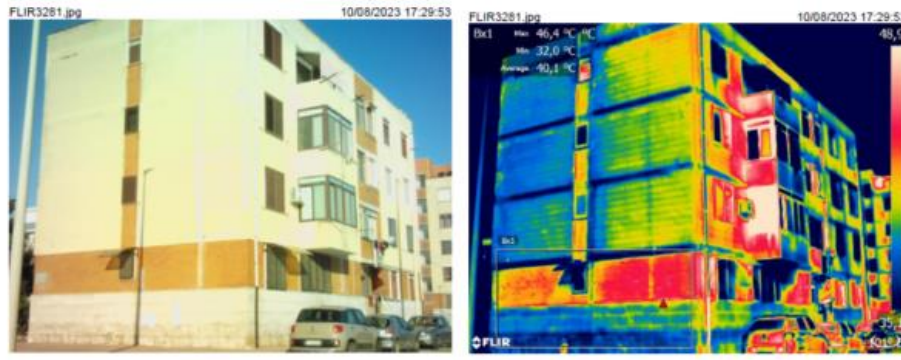
A thermographic investigation was also done on the building, which allowed the detection of thermal bridges in the software. In the picture an example of the investigation.

Figure 38: Thermography of the prospectus done by Studio Tiziano Bibò

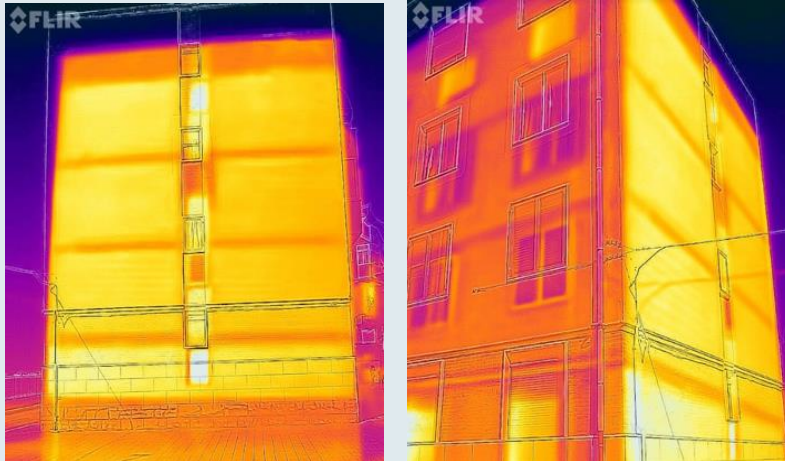
Figure 78: Thermographic tests.

Preliminary inspections are necessary to get in touch with the building and for the verification of the main information collected through the previous phase. In this step, general building dimensions are checked as well as those related to structural elements like beam and columns. Thanks to thermographic tests, it was possible to identify the load-bearing beams along the perimeter of the building (Figure 78) and inside the apartments without needing for visual inspections (Figure 79). Moreover, some non-destructive investigations are performed with the aim of verifying the presence and type of some structural elements as for example for the elevator case. Using the Ground Penetrating Radar scanning technique (GPR) it was possible to prove that the elevator case was made of RC columns and beams instead of walls.

Thermographic and thermo-hygro-metric inspections on the Italian Demo Site building, both during the day and at night [1], made it possible to highlight and limit critical issues and possible causes of heat loss in the building in consideration of its characteristics, intended use and the air conditioning technology used. The thermographic investigations also made it possible to verify the compliance with the planimetric tables of the arrangement of columns and beams.

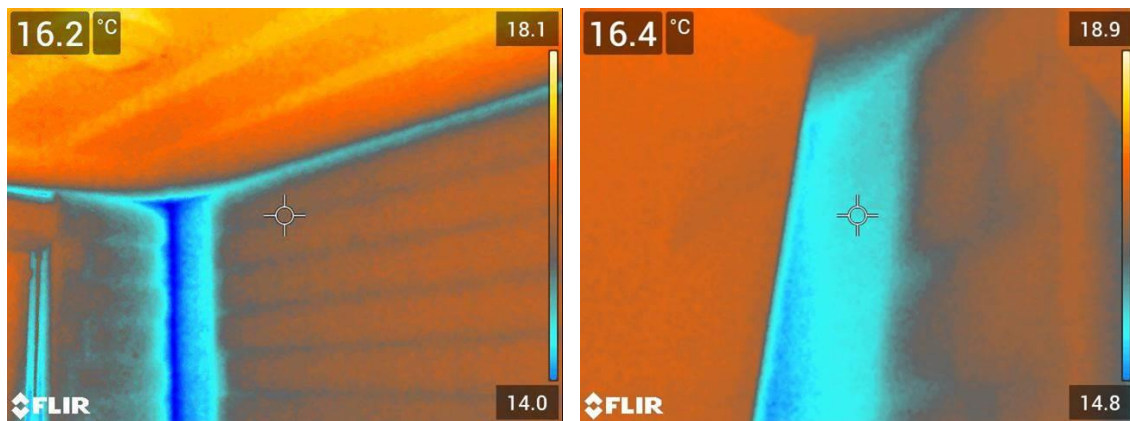
Figure 85: Upper ground floor plan, apartment A, room 5. Thermographic images T2575 e T2639.

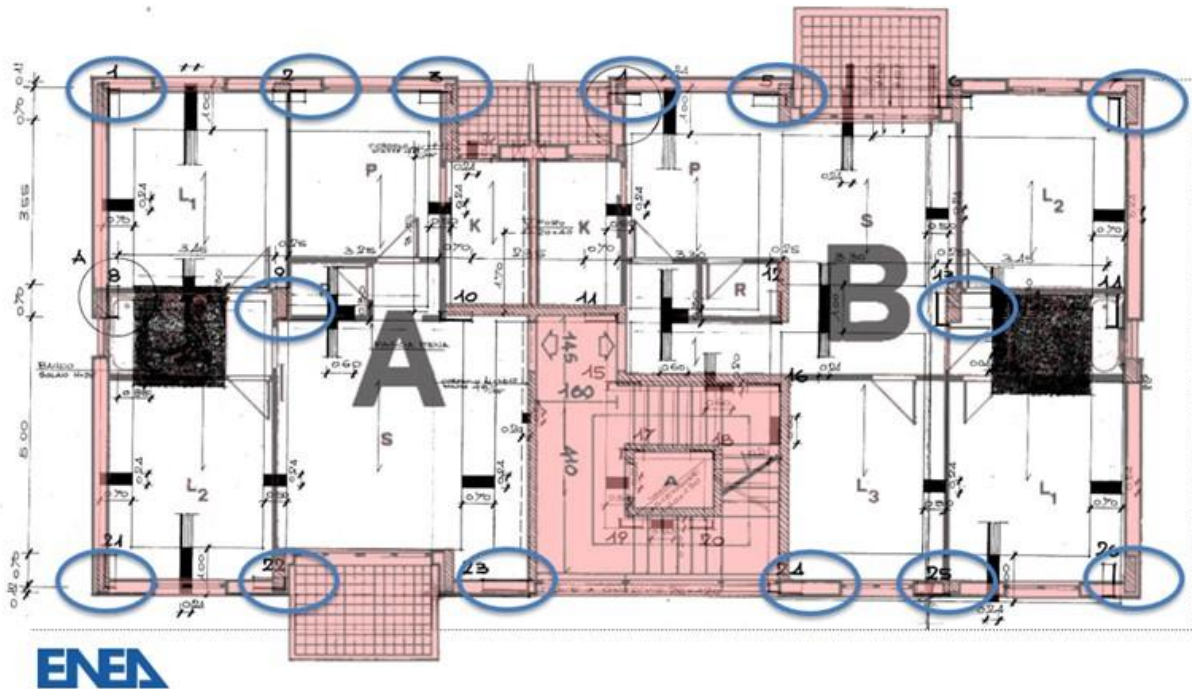
The columns that can be subjected to non-destructive testing (Figure 89), following the assessments carried out during the inspections, are highlighted in each floor plan. It was not possible to inspect apartment B in floor 1, that has been inspected during the subsequent survey campaign in February 2023.

Figure 89: Upper ground floor plan. Identification of the elements that can be subjected to non-destructive testing.

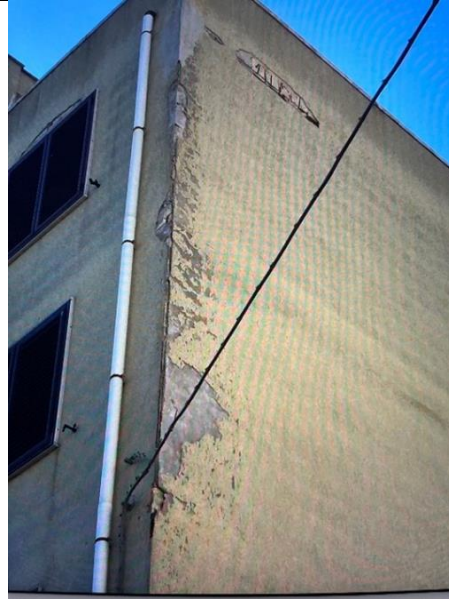
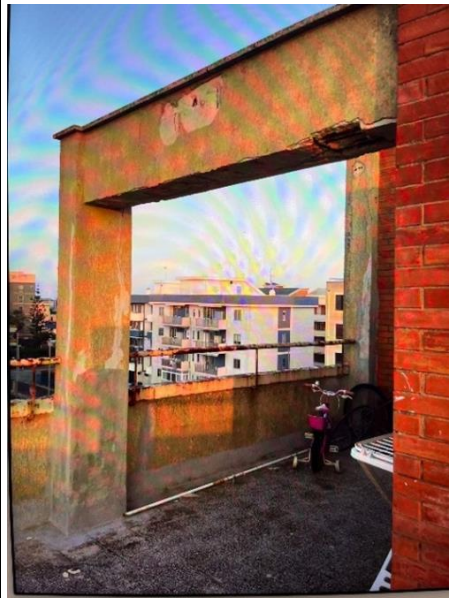
Pictures

Result = Level 2¹⁵

Presence of small signals of degradation in the structural elements at sight, but without signals of structural cracks. This level is also assigned to the buildings more than 70 years old even if they appear to be in good condition. Absence of foundation problems and absence of problems concerning gravity loads.

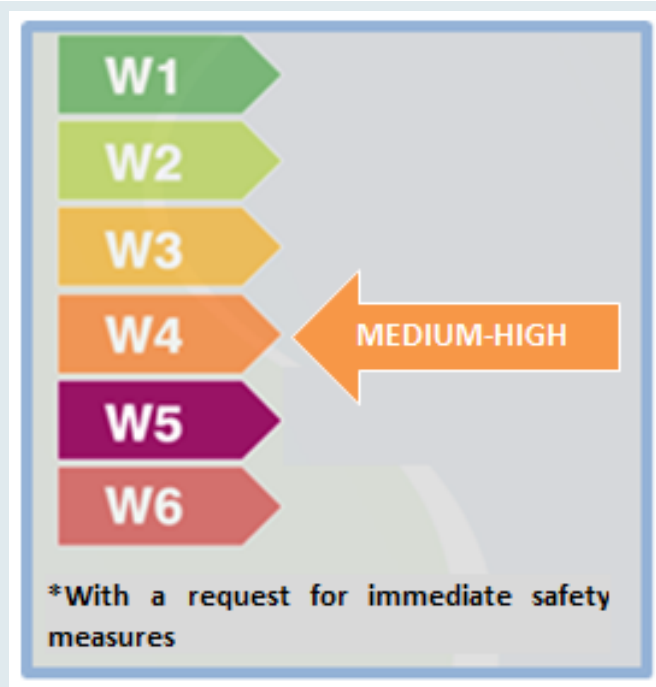
Adequately weighting the (partial) Levels of Intervention above, the device computed a synthetic Level of Intervention equal to 4 (medium-high) (Figure 90).

Figure 90: Level of intervention evaluated through the app enea

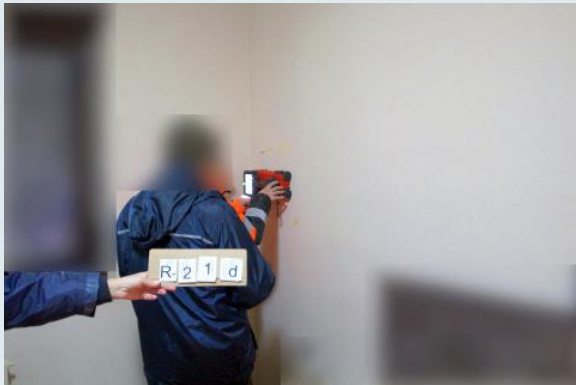
The surveys took place both inside the building (in the flats, Figure 95, and in the stairwell, Figure 96) and externally.

Figure 95: Georadar survey of reinforcement bars at column 21 on the upper ground floor, flat interior.

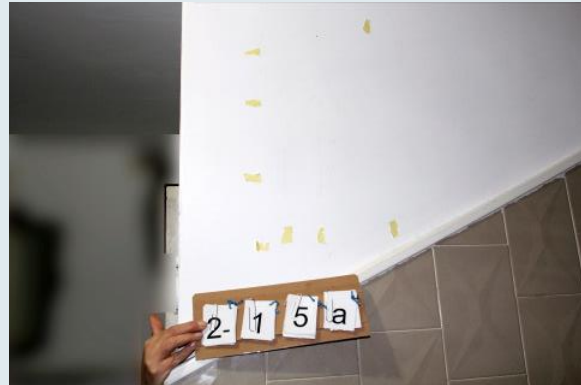
The positions of the bars, both longitudinal (vertical) and transversal, or stirrups, were marked from time to time with adhesive paper tape, Figure 96, in order to leave fewer residual traces on the flat walls, or with chalk (on the outside).

Figure 96: Labelling of reinforcement bars at column 15 on the second floor, stairwell side.

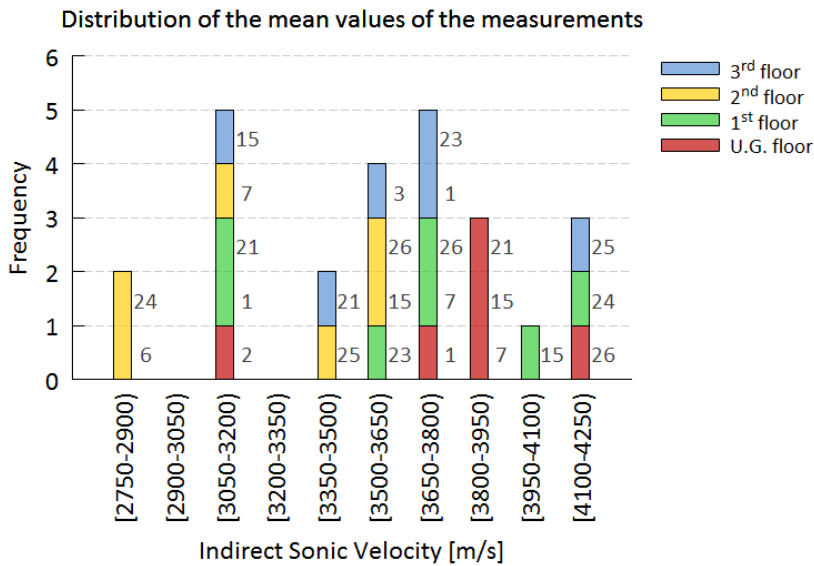
The distribution of the measurements is shown in Figure 98 and the average values of the sonic velocity measurements have a normal distribution for values between 3350 m/s and 4100 m/s whereas there are concentrations for both low sonic speed values and high values.

Figure 98: Distribution of indirect sonic measurements.

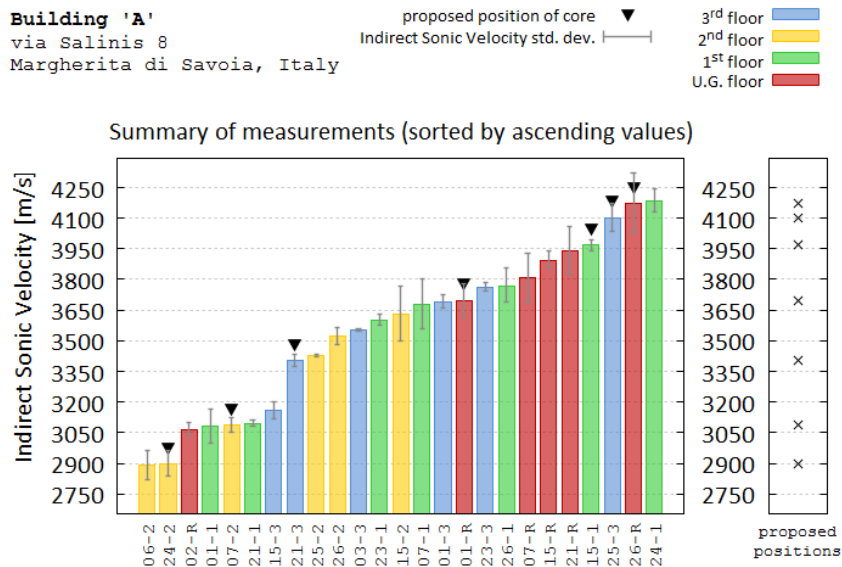
To provide more effective graphic feedback, the entire series of sonic velocity measurements, sorted by increasing value, is shown in Figure 99, on the left, and the 7 positions where core drilling was proposed are highlighted by black triangles. The right chart of the Figure 99 shows the actual dispersion of the indirect sonic velocity measurements corresponding to the proposed coring positions.

Figure 99: Sonic measurements and highlighting of proposed positions for core extraction.

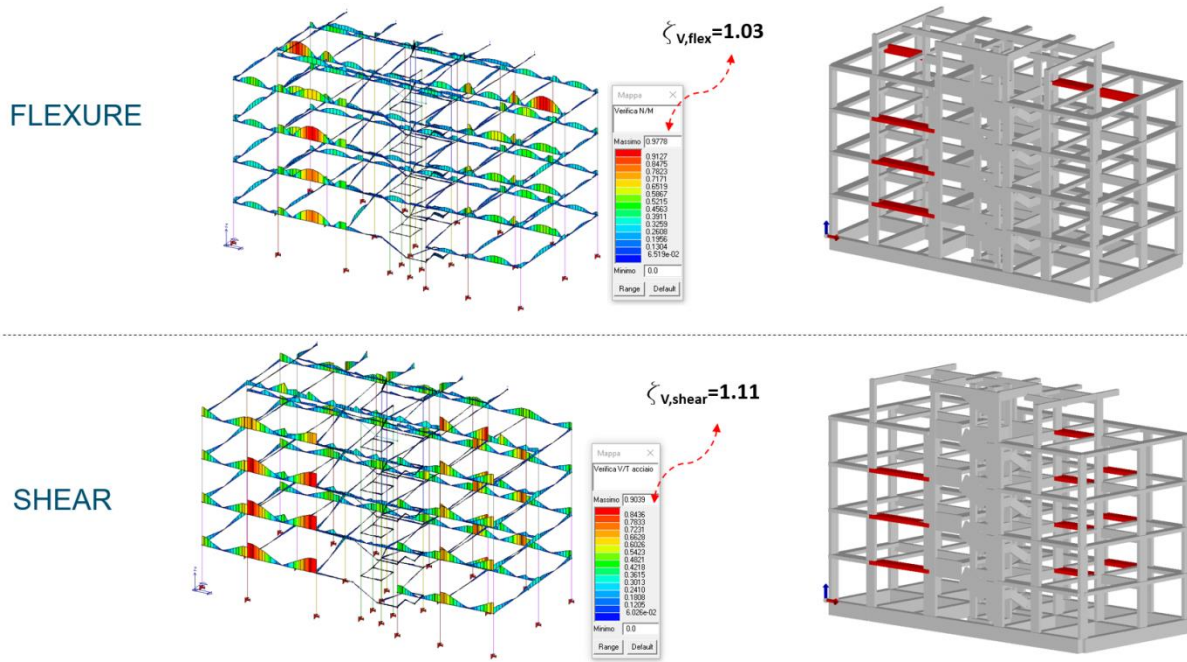
Figure 103 shows the results of gravity loads verifications under flexure and shear of column and beam members. Colormaps report the demand/capacity ratio of structural members which is always lower than 1.0 meaning that no members reach the full strength exploitation under gravity loads. This indicates that the gravity load verification is fully satisfied. Therefore, the capacity/demand ratio (safety factor) is higher than 1.0 ($C/D = 1.03$ for flexure and 1.11 for shear).

The red elements reported in the right side of Figure 103 are those that reach first the limit condition represented by the achievement of the stress equal to strength at section level.

Figure 103: Gravity loads verification.

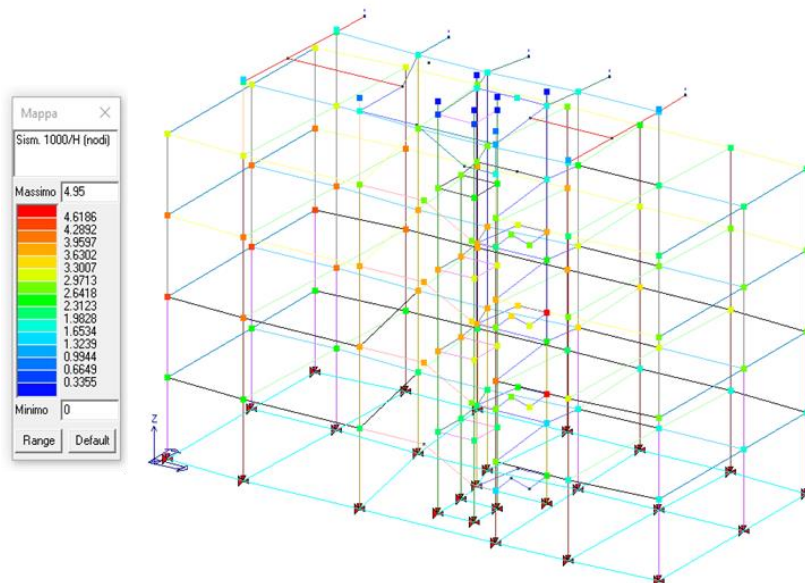
Figure 104: Indication of joint with colormap of interstorey drift values (as % of interstorey height).

As can be seen, the highest drift values are achieved by joints placed along the structure's perimeter due to some torsion effects that are related to the presence of the staircase which generates eccentricity between the centre of mass and the centre of stiffnesses.

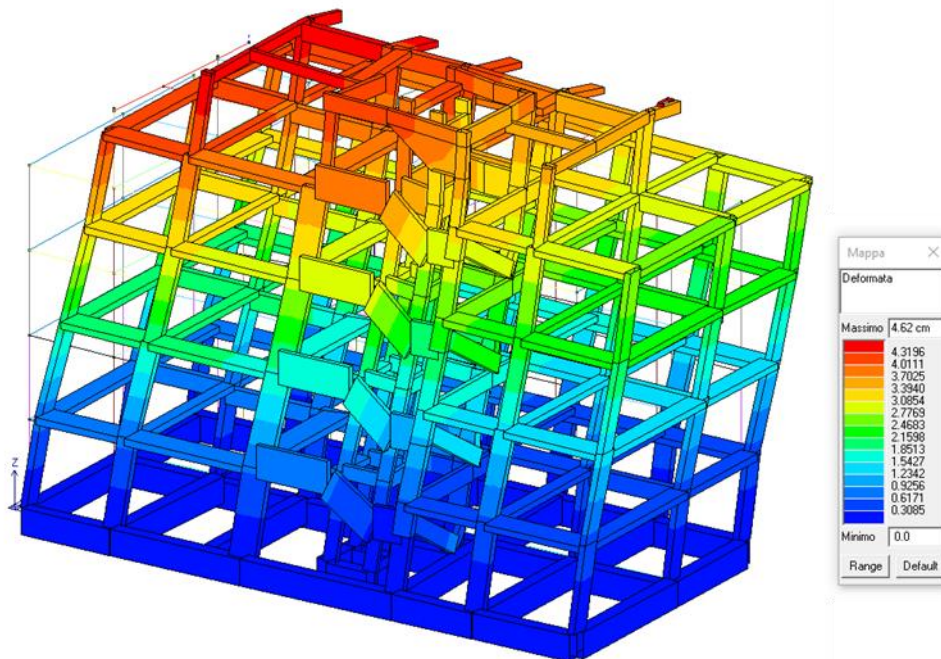
These effects can be better seen in Figure 105 showing the absolute displacements, where the rotational effects can be observed.

Figure 105: Absolute displacements at SLD limit state.

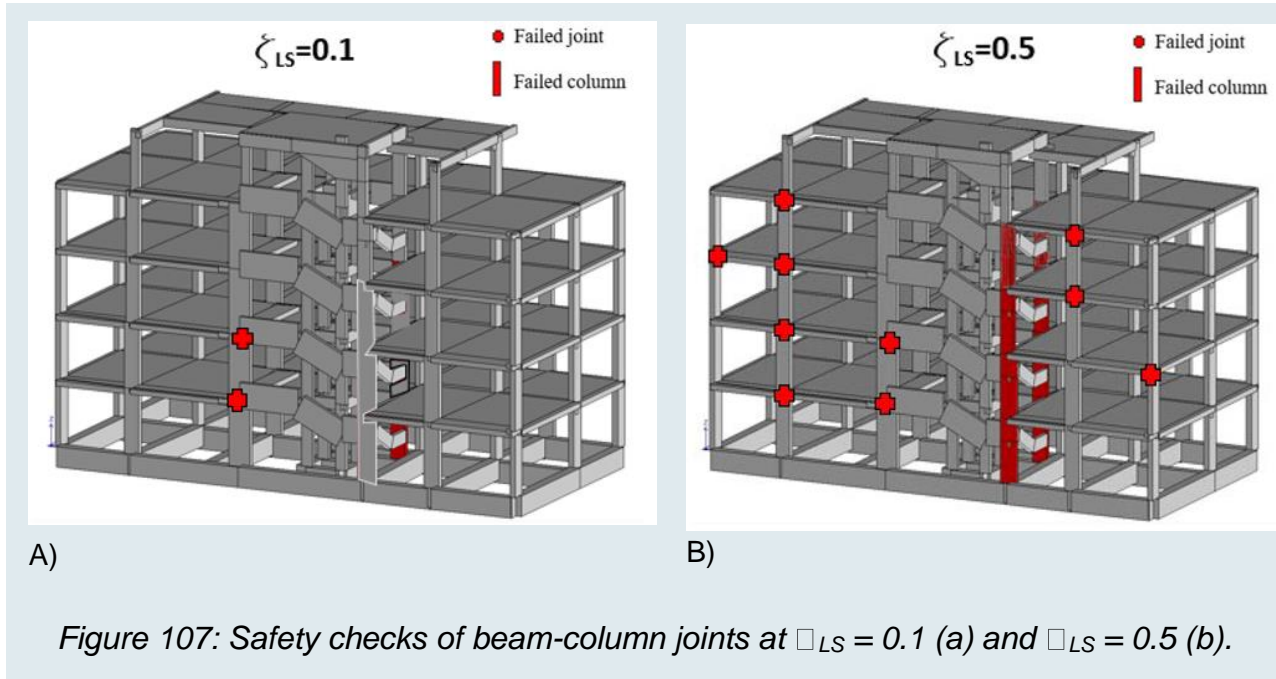
Following this procedure, the LS limit state seismic acceleration has been found and the safety index has been calculated as reported in Figure 107.a.

In fact, $\square_{LS} = 0.1$ indicates that the building structure in the as-built condition is able to sustain 10% of the design seismic action. Fully code conforming structure should have such index equal to at least 1.0. At that stage, two beam column joints and one column member fail under shear.

Increasing the seismic action till 50% of the seismic design value, there are 17 joints and 6 column elements failed under shear, as can be seen from Figure 107.b. Beyond this value of the seismic safety index, the flexure failure of beam and column start to happen and more intrusive and impacting interventions would be needed. Therefore, $\square_{LS} = 0.5$ is clearly the threshold of the seismic safety index that can be reached making interventions only on beam-column joints. Moreover, all the failed joints are placed on the building façade, thus allowing the structural interventions made by the outside, without forcing the users to leave the building.

Figure 107: Safety checks of beam-column joints at $\zeta_{LS} = 0.1$ (a) and $\zeta_{LS} = 0.5$ (b).

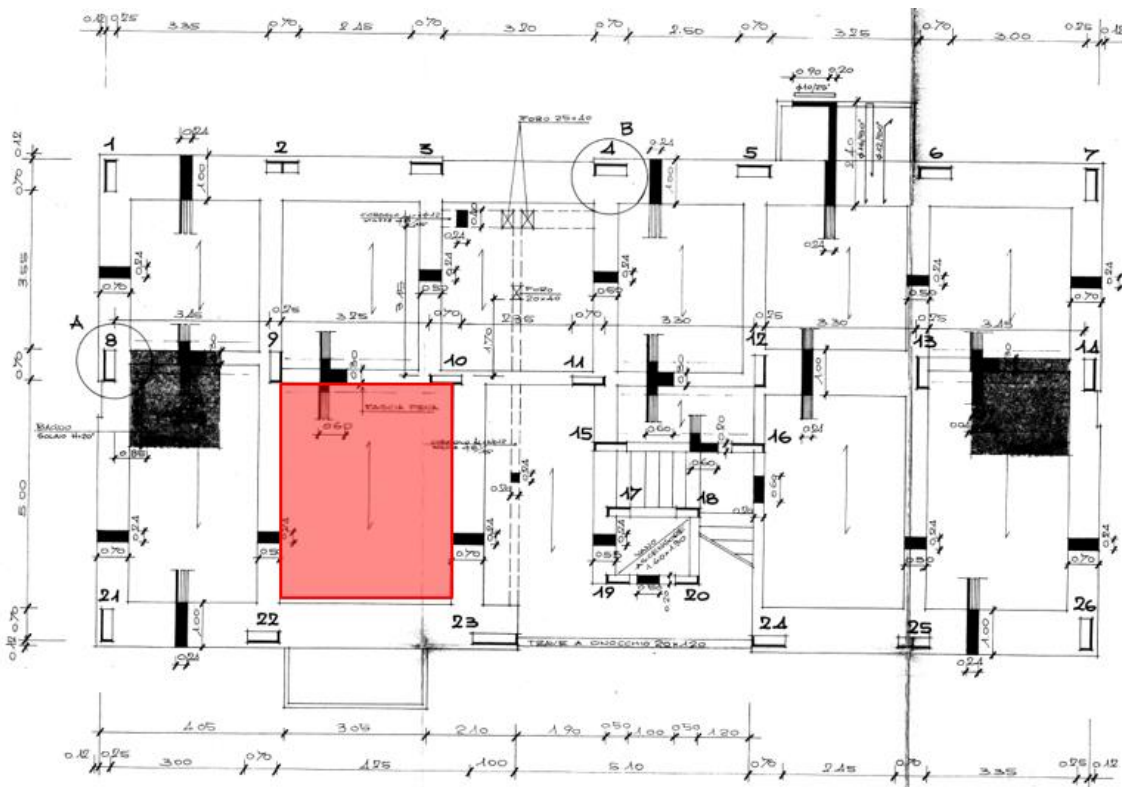
Regarding the slab structural capacity, a portion of the floor slab located on the 3rd floor (Figure 108) was chosen to perform a static load test by the application of a point load simulating a distributed load, which in this specific case, is 2.00 kN/m^2 . The load is applied through several incremental steps until the service load is reached, continuously measuring displacements through transducers placed in contact with the soffit of the 2nd floor. This test gave a positive result, given that measured deflections were lower than expected from calculations and the deflection was almost totally recovered after unloading, indicating a good structural health of the slab.

Figure 108: The 3rd-floor framework with indication of the investigated floor slab section.
